THE RESTORATION OF THE KRISHNA TEMPLE

PATAN - NEPAL

2015 - 2018

NEETA DAS

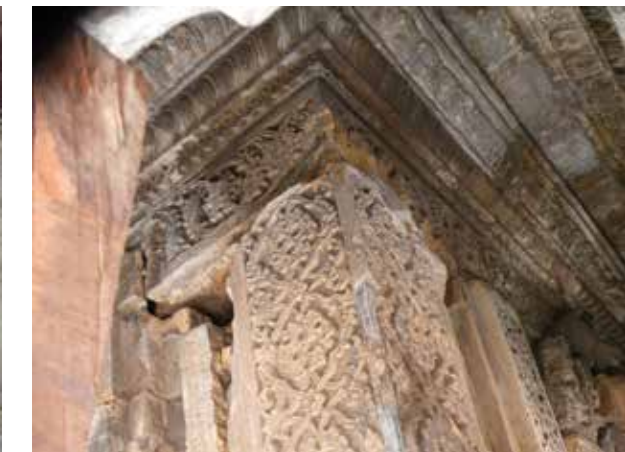
Right Bottom
Loose corner stones of the *Garbha Griha*.

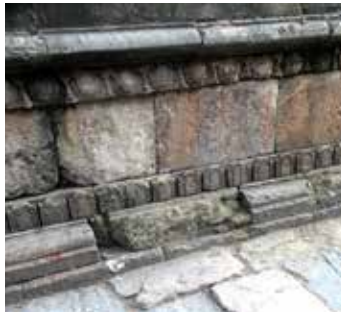
Left Top
The damaged stones on the plinth of Krishna temple.

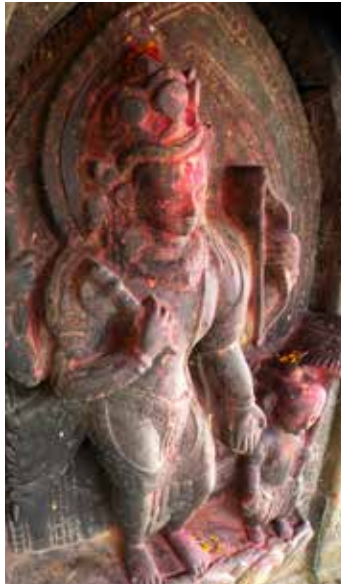
Bottom
Damage to the carved stones due to regular wear and tear and offerings of vermillion to the deities.

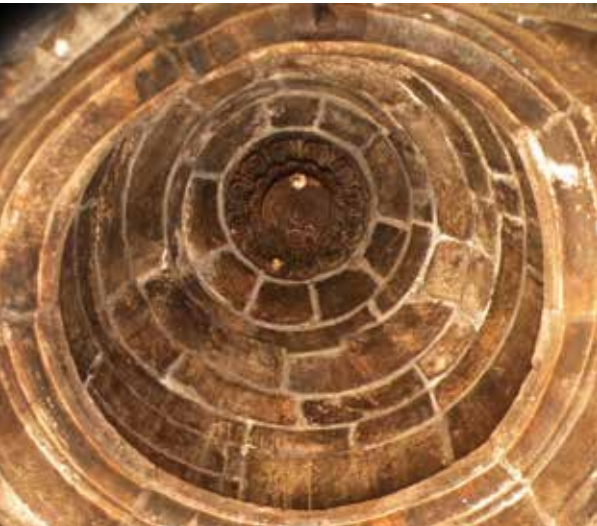
Top
The *chattris* have been pointed by an un-aesthetic grey mortar during an earlier restoration.

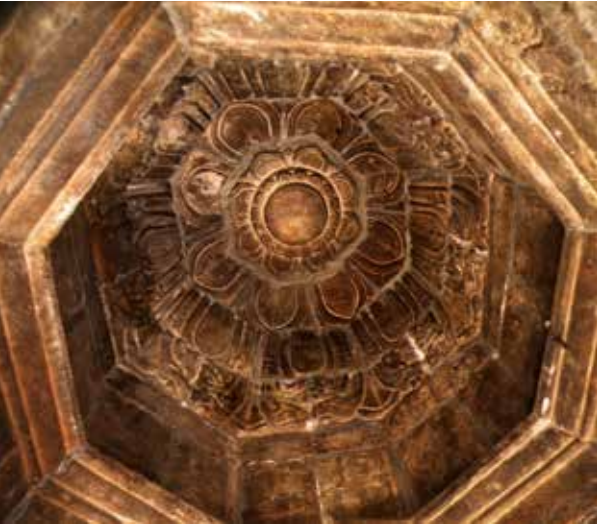
Bottom
White water seepage marks in the *Chattris*.

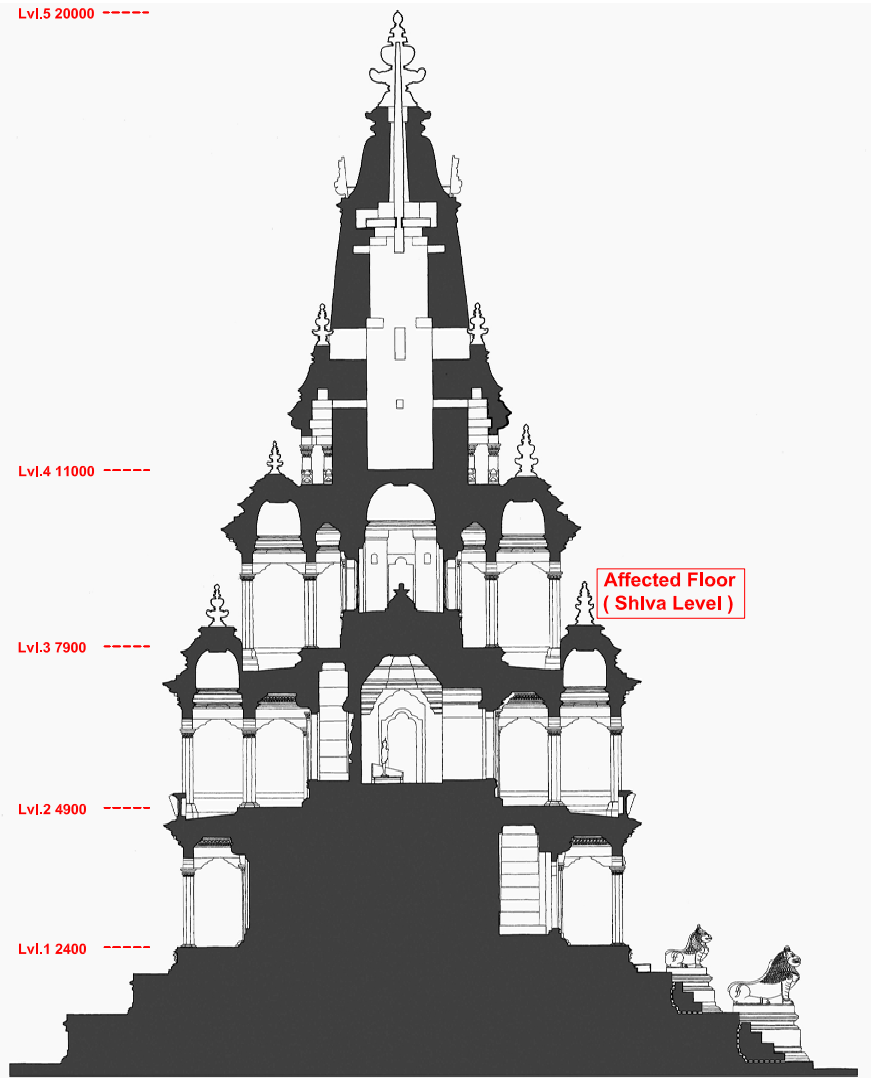
Section of Krsna Degah, Patan

The maximum damage seems to be at the Shiva level (Refer drawing indicating affected area). If one looks at the plans, the structure at this level is the most delicate and the heavy roof is supported on a slender colonnade. It is probably due to this reason that the maximum

Section Showing Affected Floor After Earthquake
Based on a drawing by Niels Gutschow

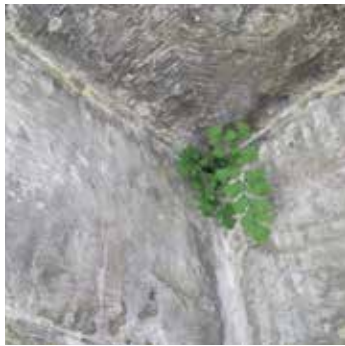
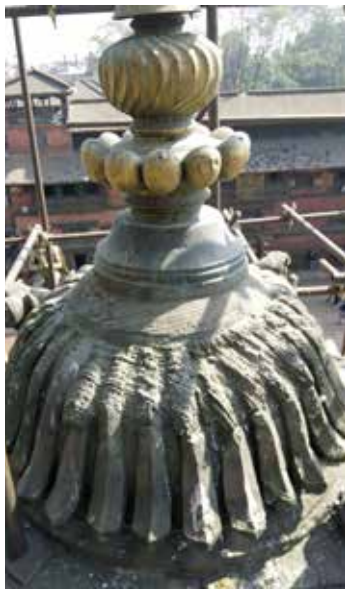
Left Top, Middle & Bottom
Water seepage, growth of vegetation, eroded stone of the *chatris*, and the internal view of the *shikara*.

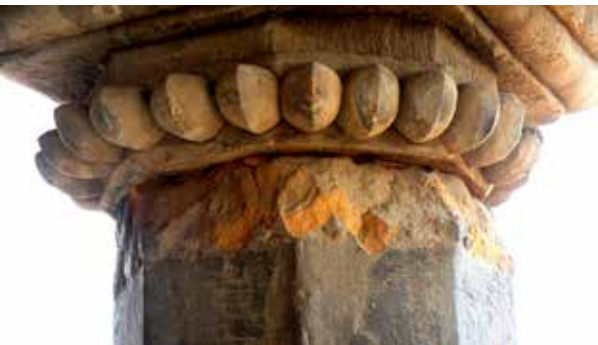
Center Top
Damaged and dislocated old pointing repairs.

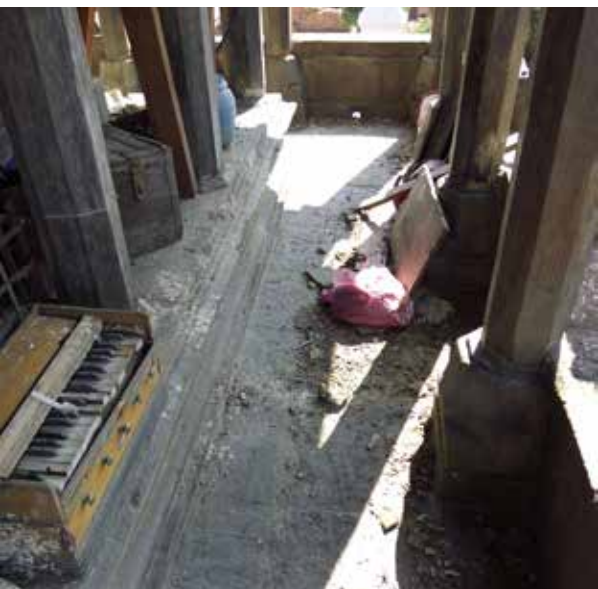
Center Bottom
Old furniture and dislocated items of the temple stored in the second floor.

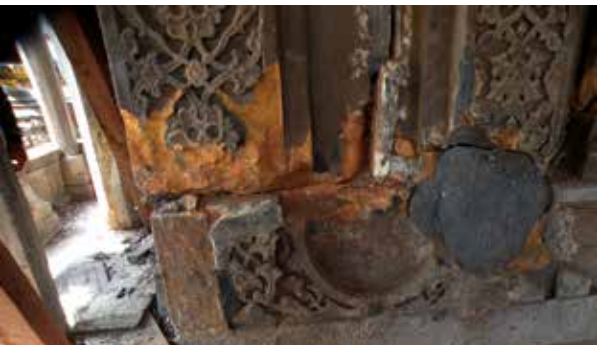
Right Top
Corner stones severely damaged.

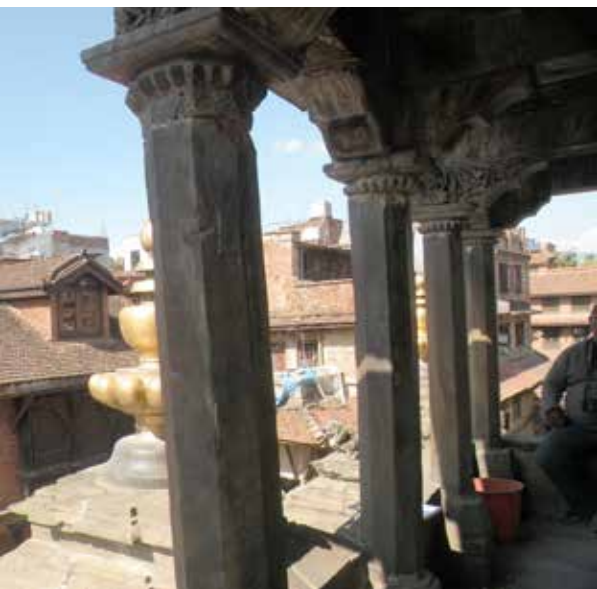
Due to the lateral movement during the earthquake, the columns had moved out of plumb; old repairs had come out; the columns, brackets, and bases of the columns had been damaged; the window frames and key stones had been dislodged; and some stones, especially at the corners of the *garbha griha* had been severely damaged. However, the inside of the *garbha griha* was surprisingly intact.

Right Bottom
The columns were out of plumb due to the earthquake.

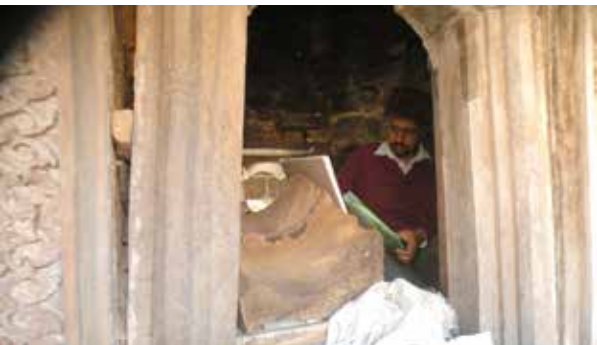
Left Top
One of the keystones on the second floor *garbha griha* had fallen off.

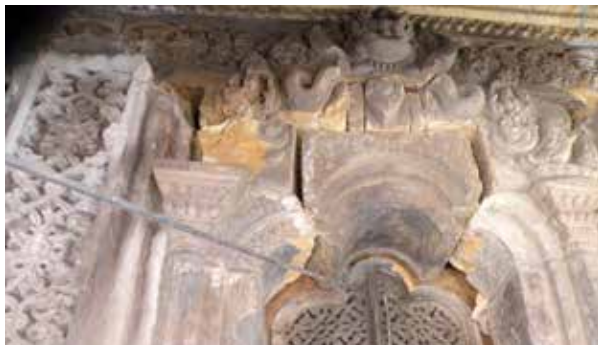
Center Top
Other keystones were loose or dislocated. they had to be propped up in place.

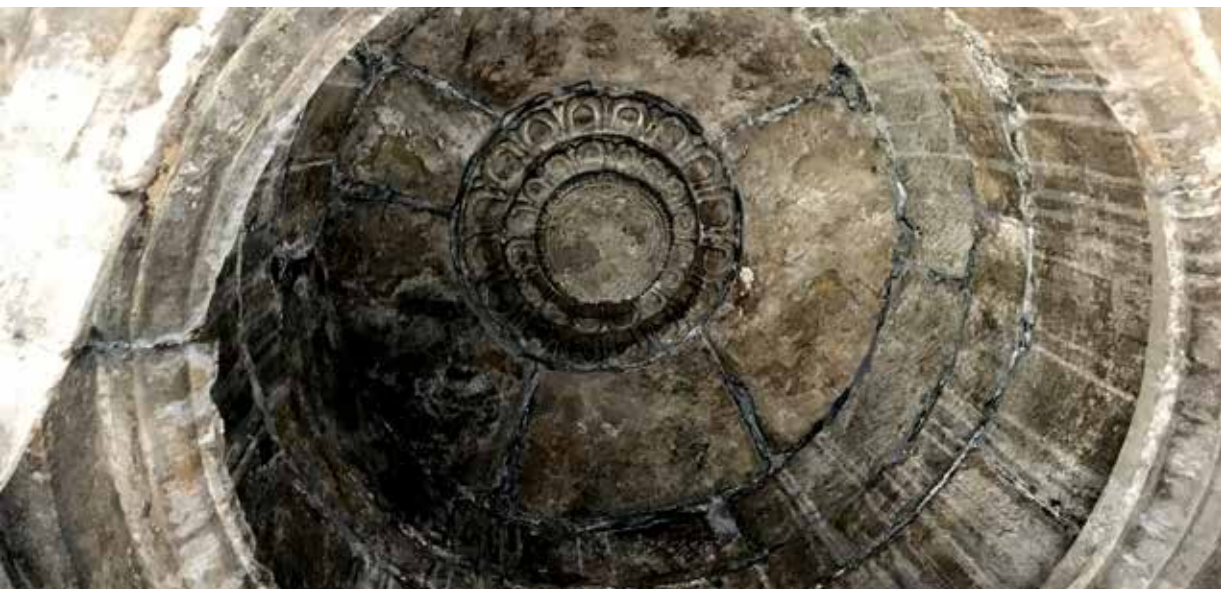
Bottom
The inside of the *garbh griha* was surprisingly intact.

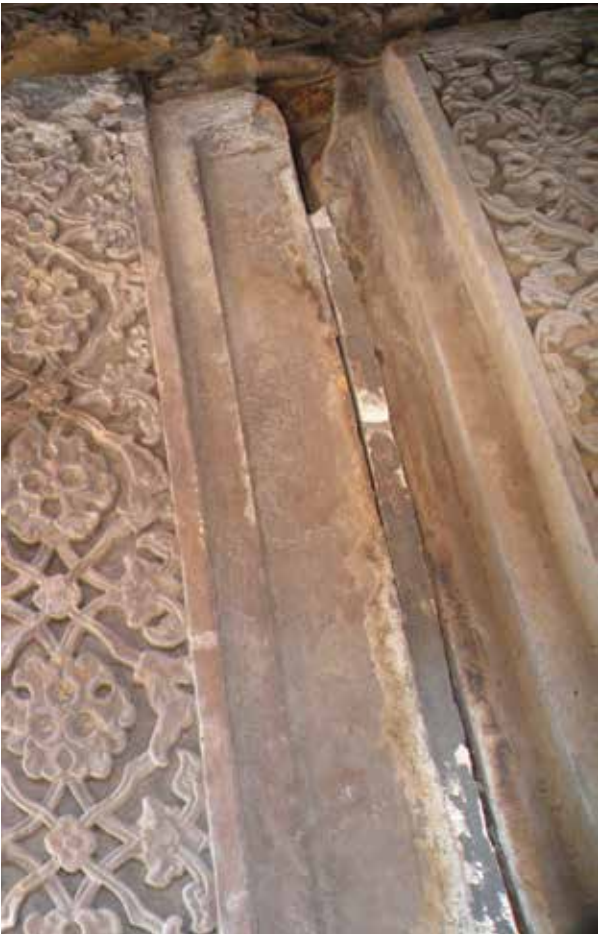
The evidence in the temple indicates that the temple has been repaired several times before. The first indicator is the level of carving one can see in the capitals and columns. In these capitals the carvings are either not of the same quality as the 'original' carvings, or are sometimes missing altogether. Although an attempt has been made to maintain the same spirit through the colour of stone and the overall patterns, on close inspection one can see the variations.

Facing page
Difference in carving style indicates they were done at different times.

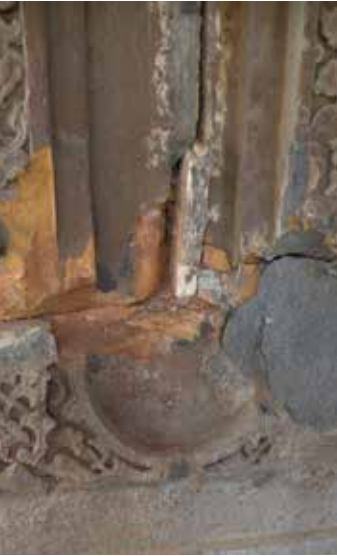
to 'fail' during an earthquake. These corner stones have moved out quite a bit and infill spaces have been filled in by new, thinner pieces of stones over a period of time. This indicates that the temple has been repaired several times in the past.

Below
Infill stones used during earlier restorations.

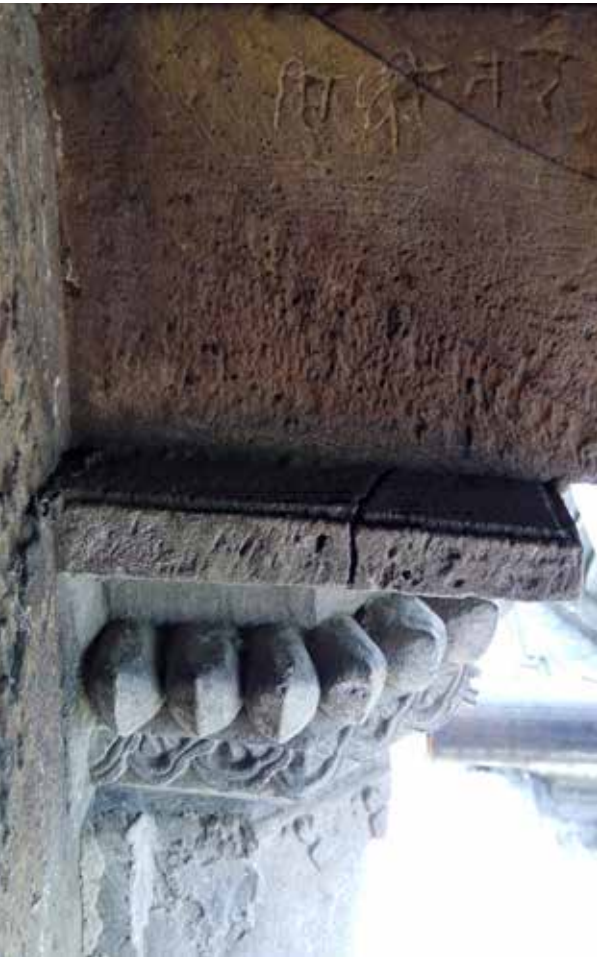
Finally, the third indication of an earlier repair is the variation in pointing. If one looks closely in the interior of the *shikara*, one can see very thin stone joints. The material used here is an adhesive made from organic sources called *silay*, made from pine resin and mixed with vermilion to match colour if needed, as told to us by a local stone mason. He added that this is made from lentil, cotton, and gum. All joints were also reinforced with iron clamps. This was perhaps the oldest method of construction used. When we collected samples for mortar analysis, we found lime, sand, and also stone dust used in the mortars. Restoration mortar in lime and *surkhi* (brick powder) was also present in abundance. Addition of *surkhi* in lime mortars is an eighteenth-nineteenth century phenomenon popularized by the British. Pointing by the 1989 team was grey in colour and some sort of epoxy mixed with cement which is an indication of the current times. Thus, the presence of different mortars indicate that the temple has been restored several times in the past.

Right
One sees very thin mortar joints in the interior of the *shikara*.

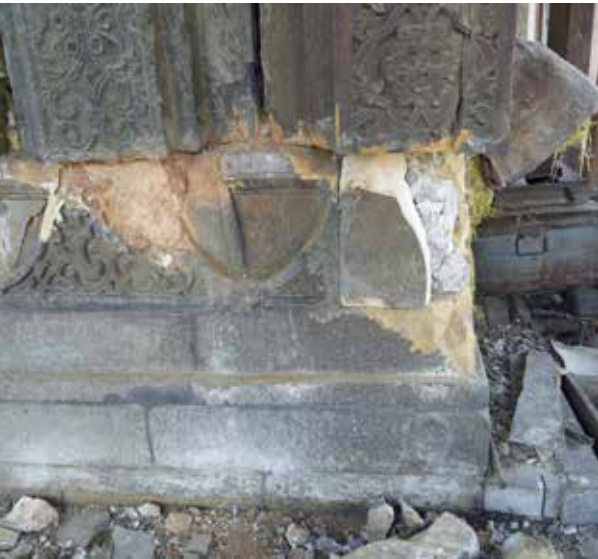
Left
Corner stone crushed into small pieces.

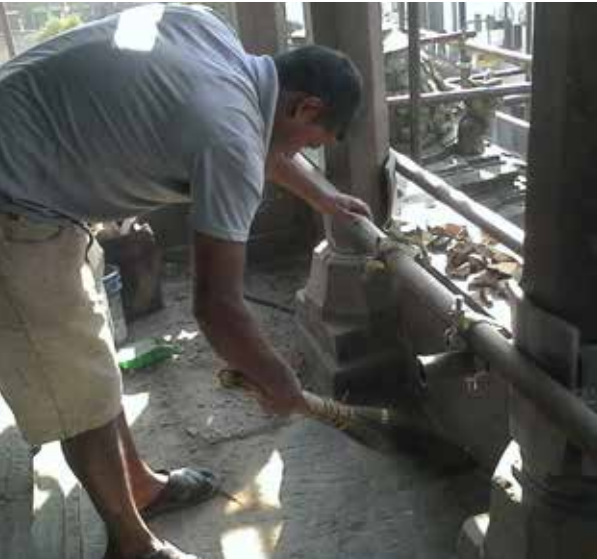
Right
The Shiva level being cleaned of debris from earthquake and pigeon dropping and garbage.

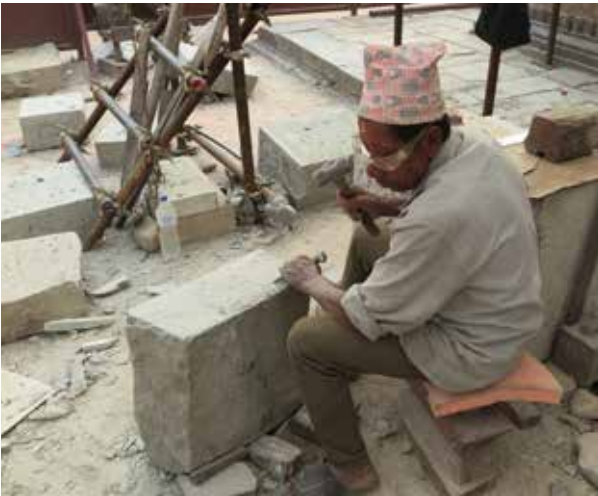
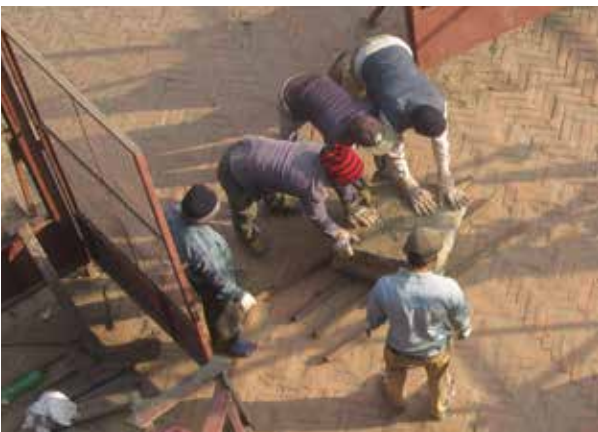
Left
Large pieces of stone were transported to the site in trucks. These were indigenously lowered and moved to the site with tackles and on circular pipes where they were finally cut into the required sizes and carved for use.
(Photos: KVPT. Dec 29, 2016.)

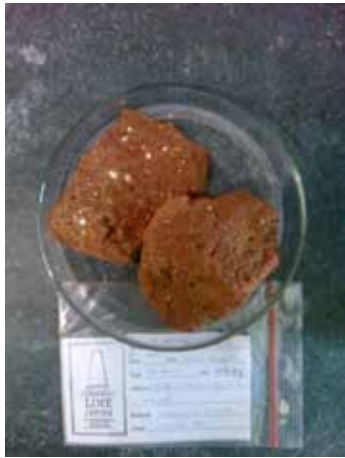
Conclusion
The lime mortar has binder 35.63 gm (air lime 23.68 gm, clay 12.03 gm) and sand 30.43 gm (1:1). After acid dissolution the aggregate has 60% of sand and 40% of *surkhi* clay.

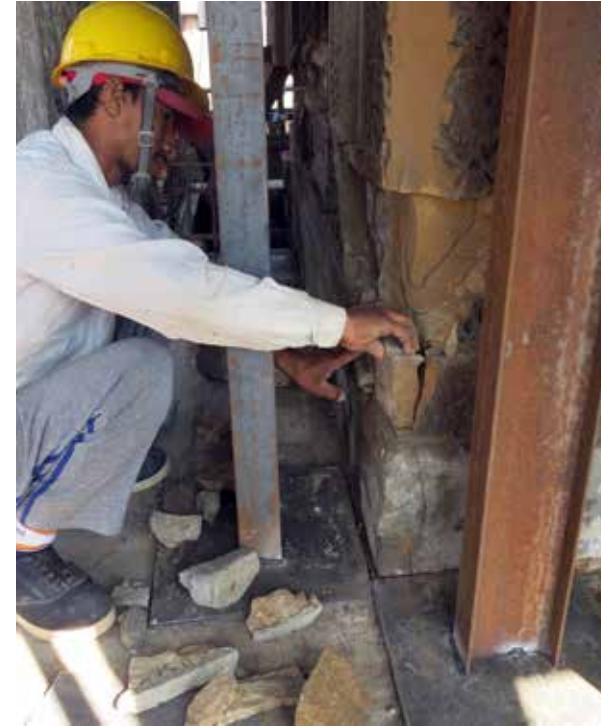
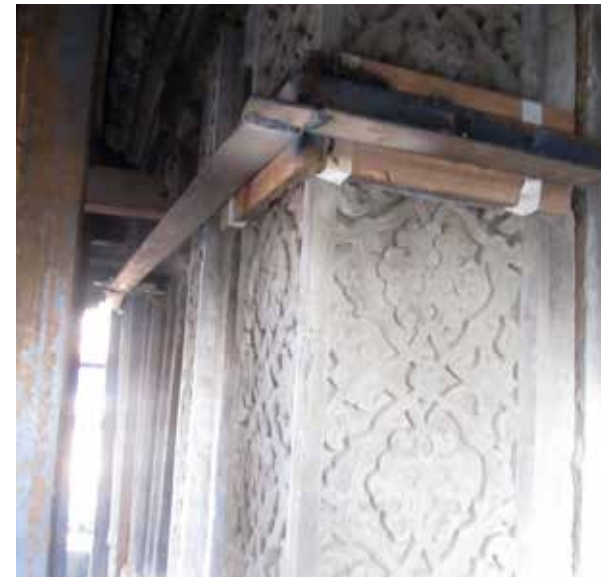
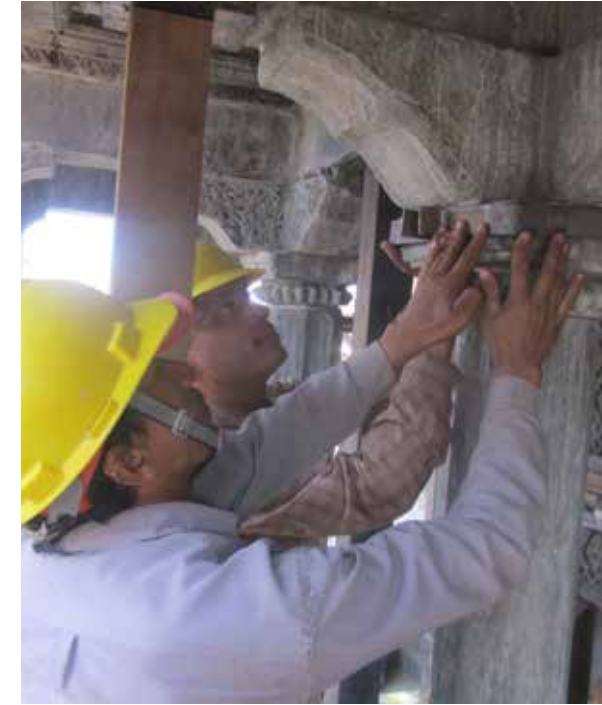
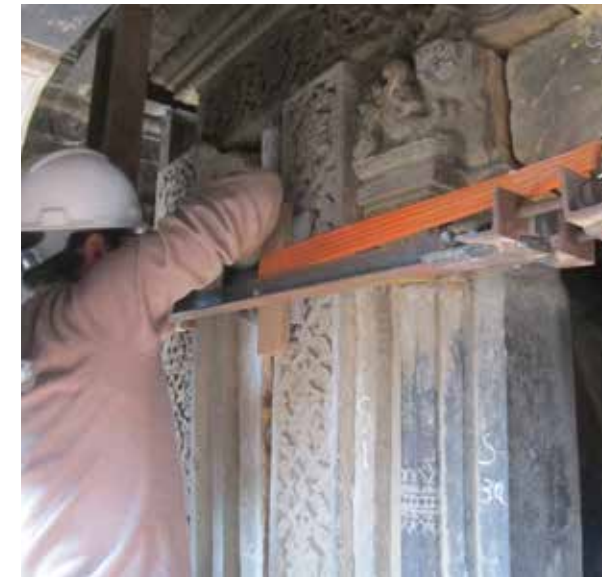
Left Top
Damaged threshold stone at
southeast corner of innermost
sanctum (*garbha griha*). Vertical
shoring, using "I" section columns
with iron base plates have been
added in the four corners of the
second floor (Shiva Temple level)
to provide additional support
for the upper structure and to
allow for in situ repair of the out
of plumb columns in the four
corners and replace the base of
corner columns.
(Photo: KVPT. Nov. 23, 2016.)

Right Top
Sample stainless steel strapping is
being tried out on the damaged
transitional piece (*cokulan*)
between the capital and the
column to hold the broken pieces
together on the east side.
(Photo: KVPT. Dec 23, 2016.)

Left Bottom
5 cm iron angle adjustable
strapping around innermost
sanctum (*garbha griha*) at Shiva
Temple level is installed.
(Photo: KVPT. Dec 06, 2016.)

Right Bottom
Fabric strap is being installed
around the stones below the lintel
level to hold the stone pieces
together before removing the
corner piece at the southwest
corner of Shiva Temple level.
(Photo: KVPT. Feb. 16, 2017.)

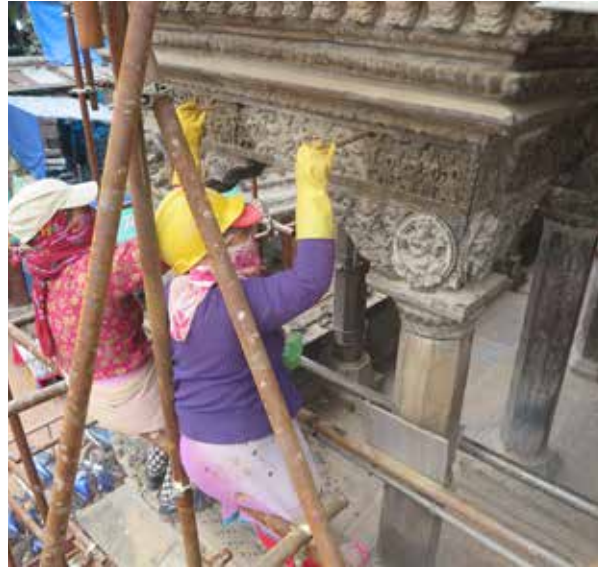
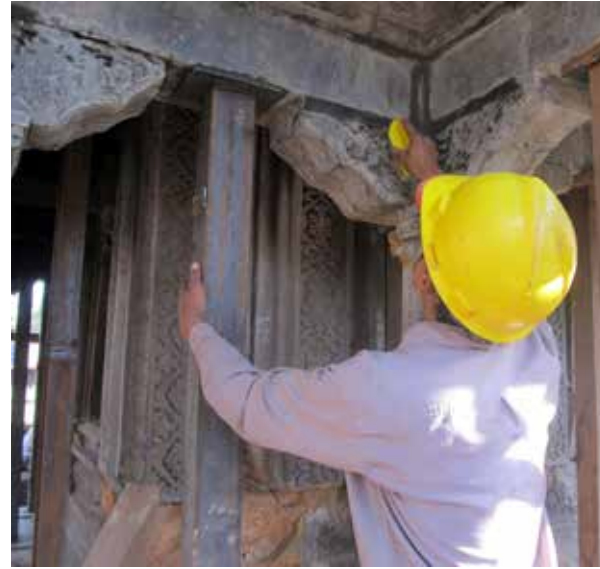
Right Top
All the stones have been cleaned to check for visible cracks. The staircase that leads to the second floor (Shiva temple level) was filled with bricks and yellow mud for shoring in future. (Photo: KVPT. Nov. 25, 2016)

Left Top
Cleaning of the carved stones was carried out at Krishna level (*Mahavharat epic*) and at ground floor (*Ramayana epic*) with soft brush and 5 % acetone solution. (Photo: KVPT. Mar. 20, 2017.)

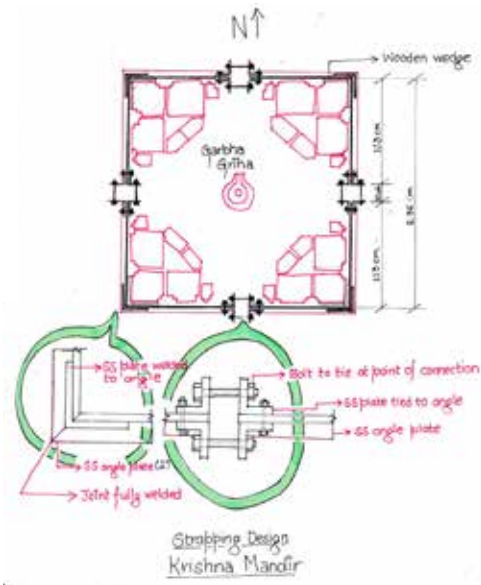
The sensitive and weakened condition of the dislodged corner stones presented concerns of further displacement or dislodgement during construction works on the Shiva level. Therefore, two levels of steel ring ties, each consisting of (4) corner pieces of 2"x2" steel angles, full pen welded in the corners, were introduced to provide confinement around the core. This strapping was originally designed to restrict the weight of the approx. 700 kg corner stones from any further outward displacement during construction, due to vibration of site works or any small tremors that may occur when the structure is in a weakened state. This ring was installed in corner pieces, bolted together and tightened to be snug to the structure, with wooden shims to protect the stones. One band was fabricated in stainless steel to remain after construction works. This will aid in reducing displacement and dislodgement in an earthquake.

Steel Angle Strapping at Core

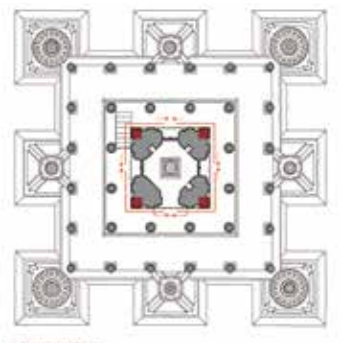
Center:
Shiva Level core survey showing observed areas of bearing to identify load paths and predicted difficulties of corner stone removal.
(Drawing by C. Corallo, January 23, 2017.)

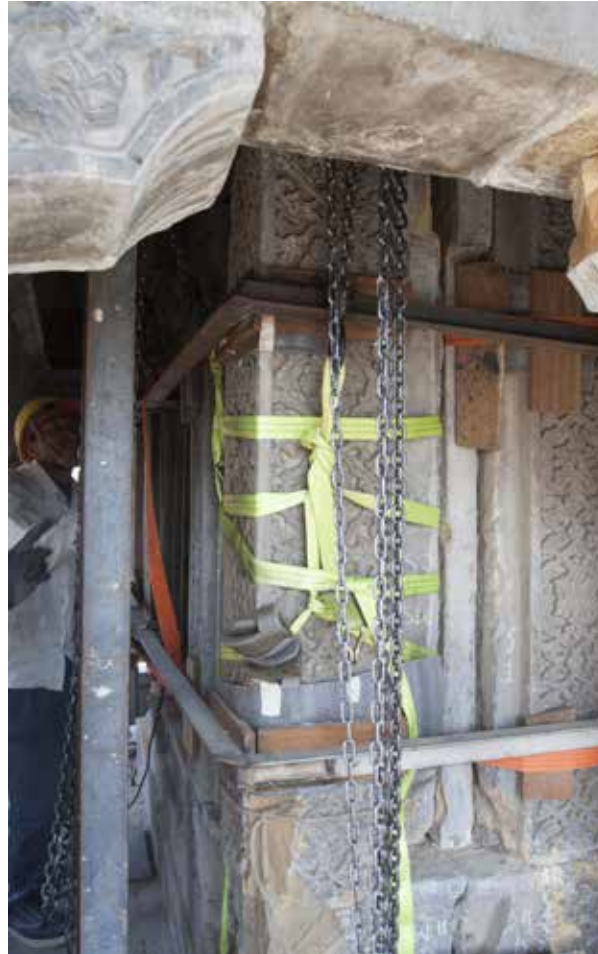
Top Left:
Southwest corner stone strapped,
connected to the chain pulley
system and ready for removal.
Steel angle belt has yet to be
removed.
(*Photograph by E. Speer, March 2,
2017.*)

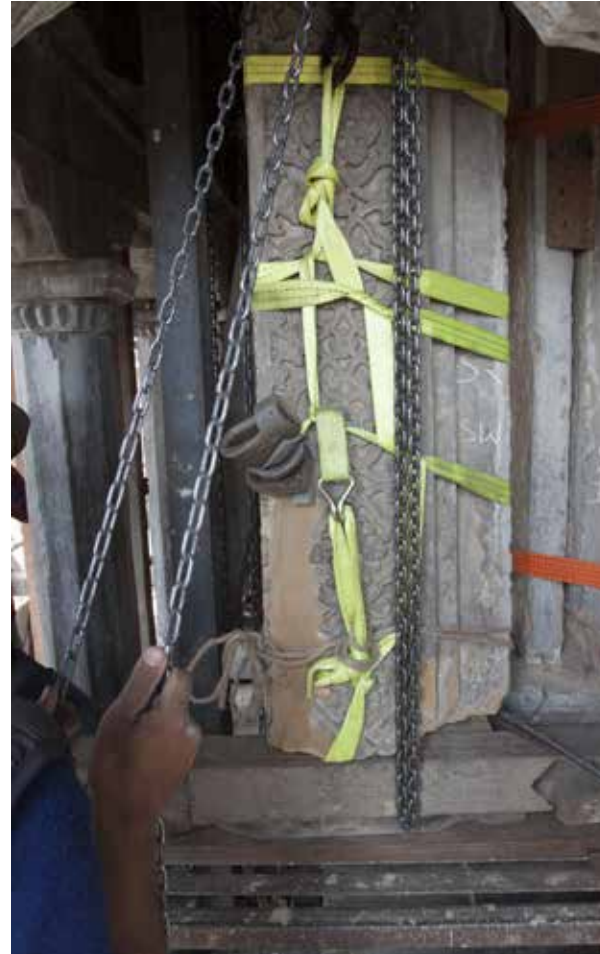
Top Right:
Southwest corner stone slowly
being removed with chain pulley
system.
(*Photograph by E. Speer, March 2,
2017.*)

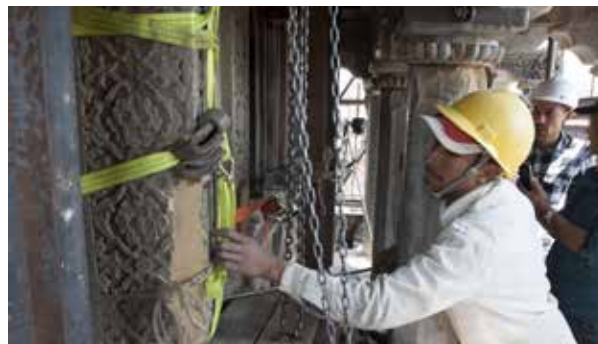
Bottom Left:
Surya Bahadur Ranjitkar checking
straps on the southwest corner
stone as it is removed from its in-
situ location.
(*Photograph by E. Speer, March 2,
2017.*)

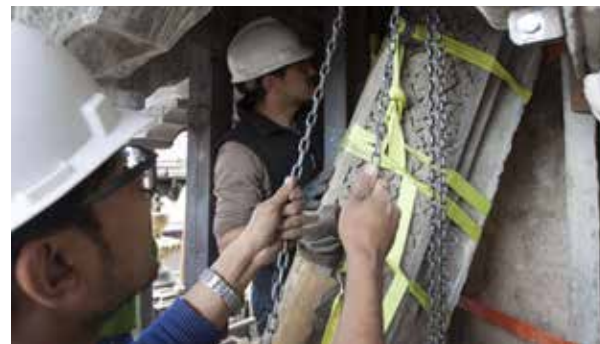
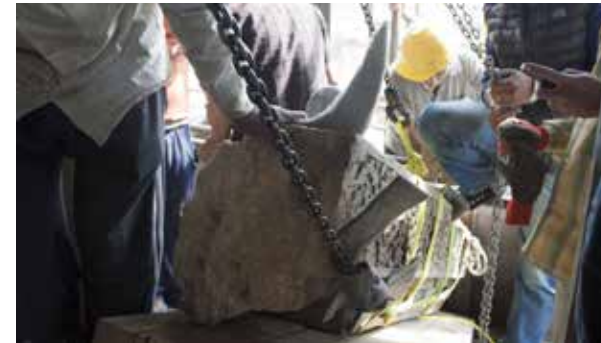
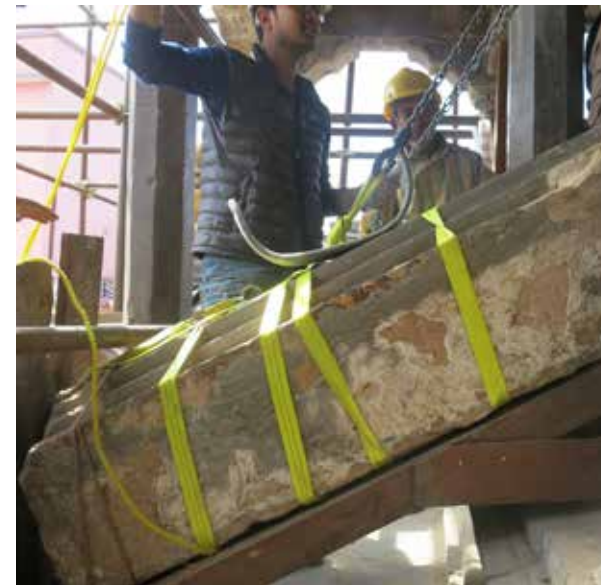
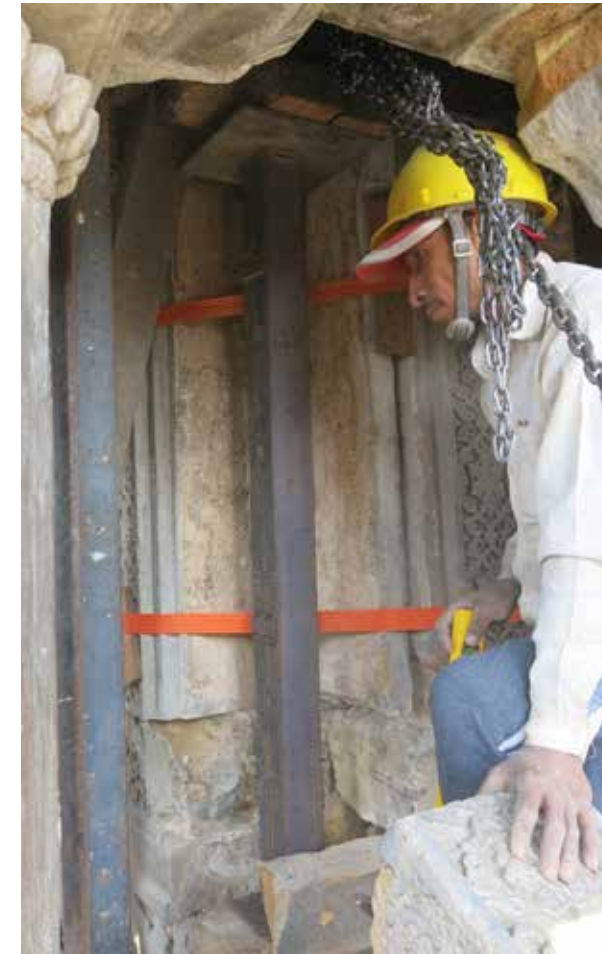
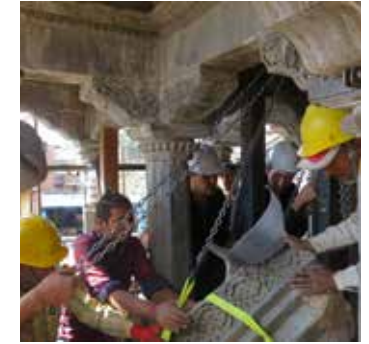
Bottom Right:
Pranam Hora operating one
chain pulley as Claudio Corallo
observes edge clearance of the
corner stone as it is angled to be
lowered out of its in-situ position.
(*Photograph by E. Speer, March 2,
2017.*)

Top Left:
The southwest corner stone
successfully removed and placed
on its temporary wooden bench.
(*Photograph by P. Amatya, March
2, 2017.*)

Top Right:
Pranam Hora and Evan Speer
operating the chain pulleys as
the site team helps guide the
southwest corner stone into place
atop its temporary wooden bench.
(*Photograph by P. Amatya, March
2, 2017.*)

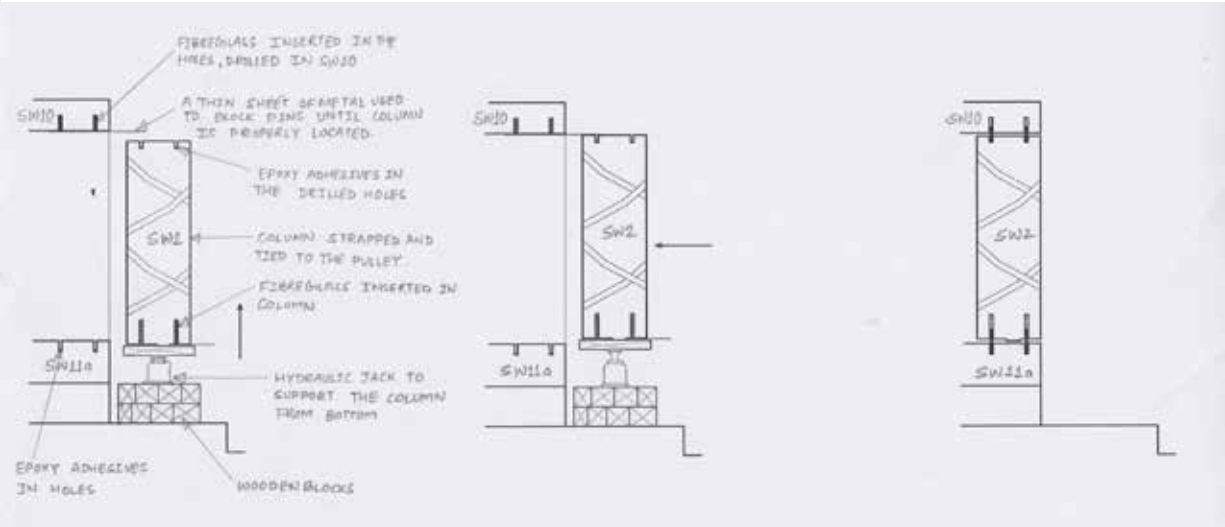
Proposed Southwest Corner Column Replacement Procedure:

The southwest corner stone was chosen as the first column to be replaced, because it had the least amount of bearing area (25 cm²) and had the largest joints allowing easiest access to install the strapping around for removal. The stone was removed on March 2, 2017 per the procedure described in the preceding pages.

The proposed design for the replacement of the column is shown below. This incorporated two dowels both at the top and the bottom of the corner stones, which would be inserted into the upper dowel hole and allowed to drop into place when the corner stone was reinserted.

Stage 2: Push the corner stone into the horizontally place with copper sheet underneath, holding two stainless steel dowels each, inside the column (for bottom connection) and in the upper stone (for top connection). Once in place, the copper sheet was removed to allow the stainless steel rod to drop into place.

Stage 3: Remove the straps from the corner stone as the joints are pointed with mortar.
(Drawing by P. Amatya, April 4, 2017.)

The column was reinstalled on May 30, 2017, and the the final configuration implemented by the site team involved only a single 16mm stainless steel dowel in the base connection, and no added reinforcement to the top of the corner stone. Two 12mm horizontal fiberglass rod dowels were later installed in bed joints at third points from behind to secure into mortar beds of the interior triangular stones, but the capacity and configuration of this connection is not equal to the proposed vertical pin. Horizontal dowels in this configuration will experience tension with the introduction of lateral (horizontal) forces during an earthquake as opposed to shear in vertical pins. This results in a lower strength (dependent on friction between pins and mortar), and changes the behavior of the original structure. But this detail does provide added cohesion to the structure and adds restraint to the corner stone against overturning.

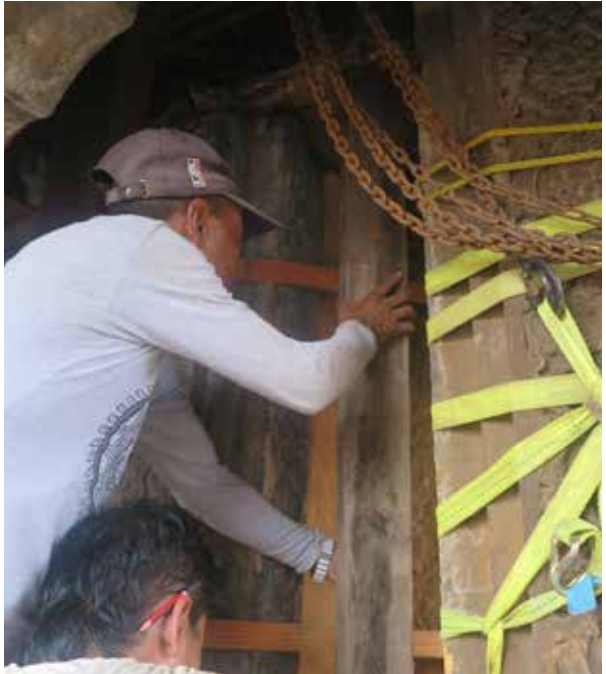
The existing configuration of the flat iron pins was ultimately recreated with 10mm stainless steel pins by the site team. As there was no dowel inserted into the top face of the stones, the stainless steel pins inserted should have been larger than 10mm to provide added corrosion resistance and tensile strength to hold the corner stones against movement.

Vertical dowel holes at the base of the corner stones were tapered with a drill to allow for easier alignment of the dowel holes.

Top Left:
Newly installed base stone with oversized hole to accept 16 mm stainless steel dowel. *(Photograph by A. Basukala, July 23, 2017.)*

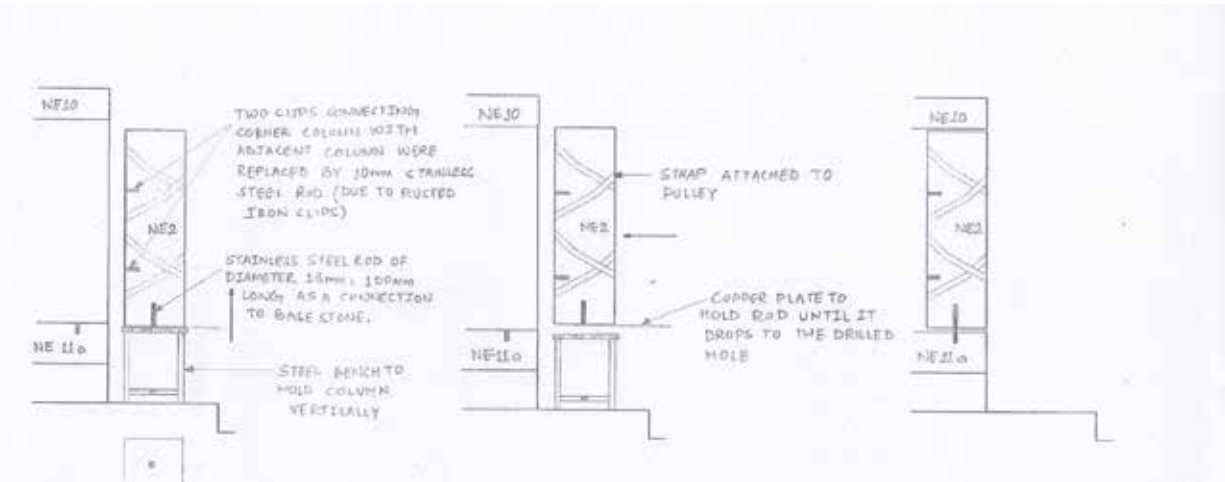
**Bottom:
Northeast Corner Stone Replacement Procedure:**

Note: Only one stainless steel rod was inserted into the corner stone by the site team, as it was judged that the corner stone's cross-sectional area was too small, and included a cracked corner, to support multiple dowels. *(Drawing by P. Amatya, August 17, 2017.)*

Stage 2: The corner stone was pushed horizontally into place with a copper sheet underneath, holding a 125 mm long, 18 mm diameter stainless steel dowel inside the corner stone. Once in place, the copper sheet was removed to allow the stainless steel rod to drop into place.

Stage 3: The straps were removed from the corner stone as the joints were pointed with mortar.

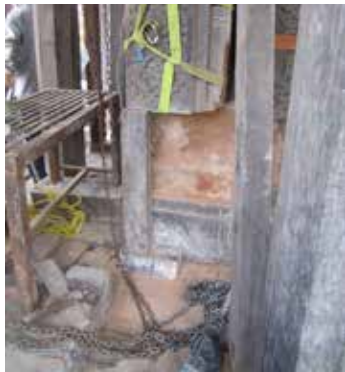
Top Left:
The northwest corner stone was bearing more structural weight on less bearing area than the other corner stones. The precarious position is seen, with wood propping that had been mandatory after the soft base stone had blown out during the earthquake.
(Photograph by L. Batty, October 23, 2017.)

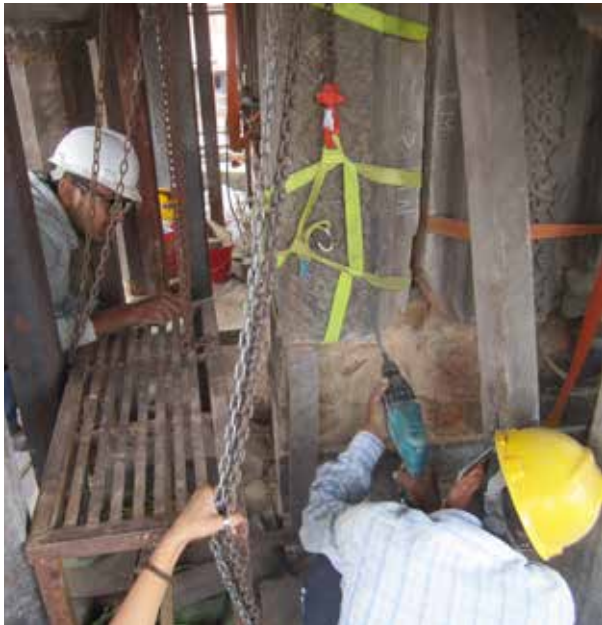
Center:
After additional propping and shoring was installed, Surya Bahadur Ranjitkar drilled and chiseled portions of the base stone to loosen the corner stone and allow for removal.
(Photograph by L. Batty, October 23, 2017.)

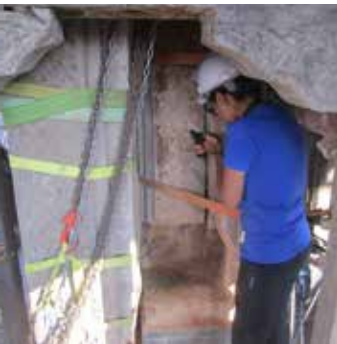
Right Top:
Pooja Amatya observing the condition of the northwest corner after the corner stone had been removed.
(Photograph by L. Batty, October 23, 2017.)

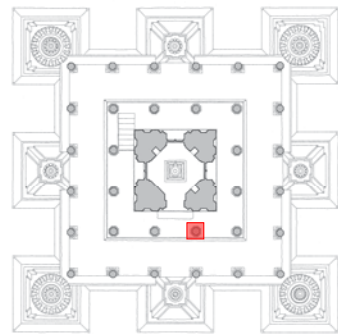
Center:
Bearing condition of column
S3 showing loss of section and
spalling of the outer surfaces,
evidence of weakened stone and
rocking during the April 25, 2015
earthquake. The column currently
bears on approximately 50% of its
original cross-section.
(Photo by P. Amatya, July 13,
2016.)

Loss of section of the column, combined with being out-of-plumb, means that this column must be replaced. A replacement to this type of column should include a vertical fiberglass or stainless steel dowel extending from the beam to bracket to capital to the column shaft, and also from the column shaft to the base. This would allow the energy dissipation of the rocking of stone elements, but would retain the load path and resist the dislodgement of the stone elements by providing vertical continuity.

There was hesitation in the site team to replace this column, due to concern about the shoring and relieving the load. In January 2018, the team on site proposed to patch the octagonal column as a temporary measure, but ultimately the column should be replaced.

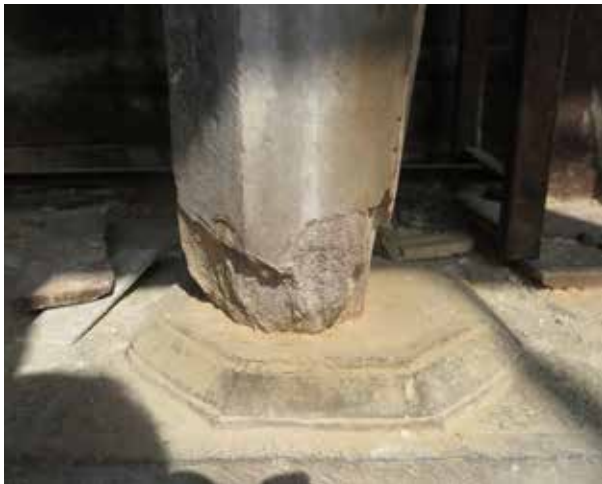
Right:
Elevation of freestanding
stone column S3, seen from
the southeast. This column
experienced substantial damage
and loss of section during the
2015 earthquake.
(Photo by P. Amatya, July 13,
2016.)

Many of the 20cm (8”) octagonal columns experienced movement during the earthquake and do not properly align with the capital elements. Some capitals experienced loss of section, and one column in particular, on the south line of the inner colonnade, one column experienced extensive damage. It is stipulated that this column was likely made with a lesser quality stone, and its origin is unknown.

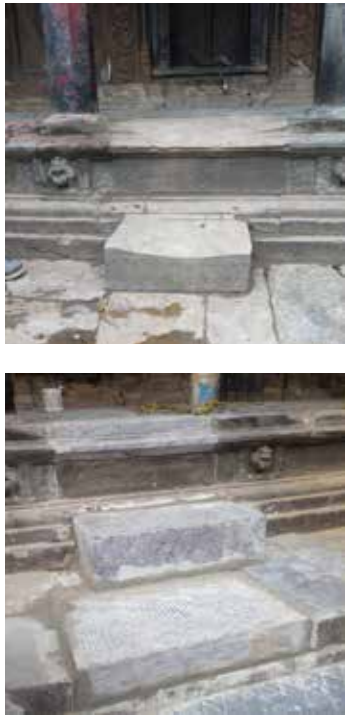
Left Top
The deteriorated and damaged stones of the main entrance step.
(Photo: KVPT, July 01, 2018.)

Left Bottom
The damaged stone steps of the main entrance of the temple have been replaced with new ones.
(Photo: KVPT, July 06, 2018.)

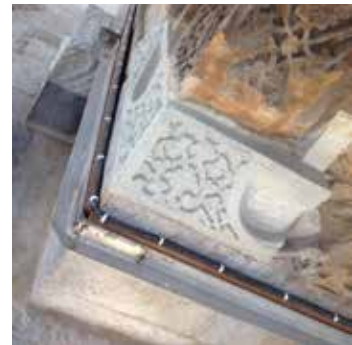
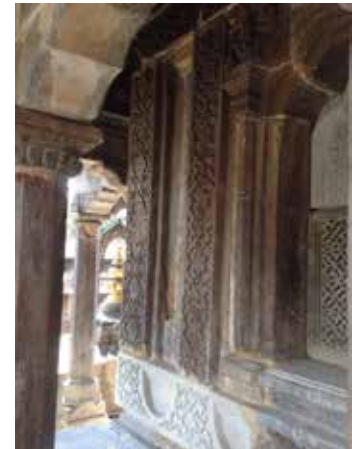
Severely damaged corner stones

Some stone have been severely damaged and could not be repaired. Among these were the four corner stones, as mentioned above. The stones at the plinth level of these corners were most damaged. The damage was severe in all the four corners. The vertical monolithic stone columns were out of plumb and the eccentric loads from above seemed to have damaged the stones below. Large chunks of pieces had fallen off not giving the column enough base support to rest thus making them unstable. Since the stones had been reduced in size and shape, they had to be replaced by new carved stones .

Before any work was done the un-stable stones had to be propped and braced for the safety of the workers. It was recommended that the areas be inspected carefully and a judgment made on the method of dismantling. It was also recommended that proper machinery be used for this and care was to be taken so as not to damage the stone further. Temporary protection like bubble wrap and foam sheets were recommended to be tied around the stone to prevent crushing of edges during dismantling. The same precautions were to be taken while erection of repaired or new stone. Stone had to be replaced with a similar stone matching in property and colour and fixed as recommended.

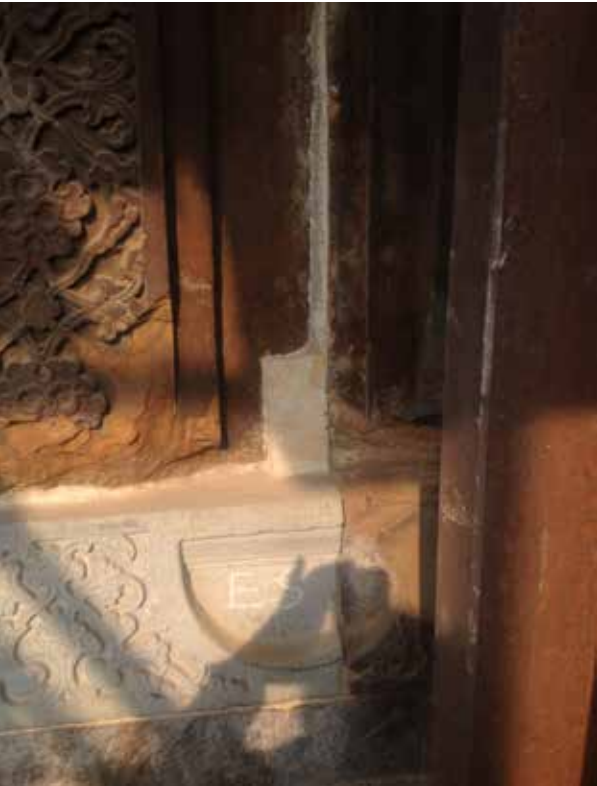
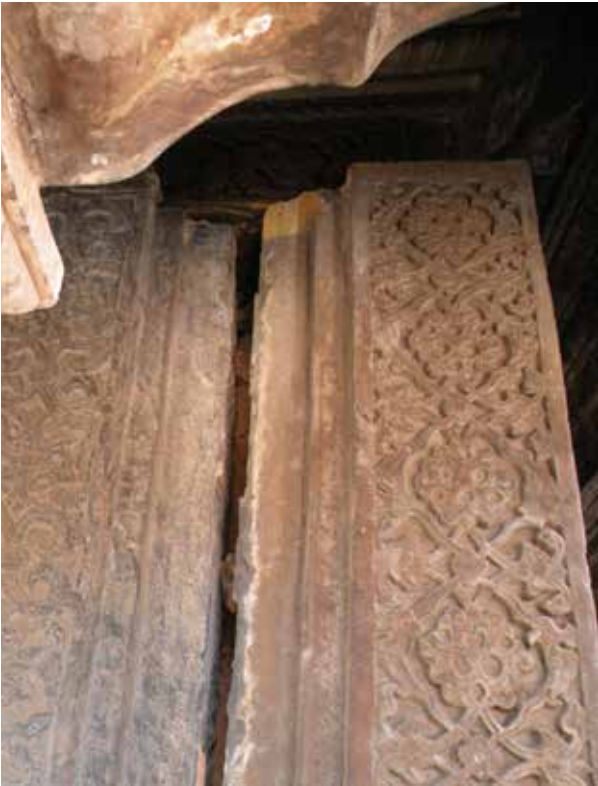
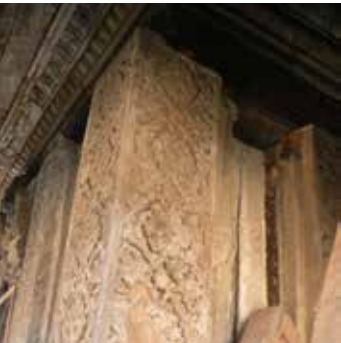
Due to the movement of the corner stones away from the load bearing stone walls, large gaps could be seen. The core behind the outer wall became visible. Old repair mortar of lime and *surkhi* (brick powder) crumbled out of the open joints. Old repair stone pieces and layers became evident. Since there was no way to inspect the brick core, if any, behind the stone walls, ultra sonic tests were conducted. However, in the absence of proper vantage points for the placements of the nodes, the tests were non-conclusive. Much later, during repairs, when the inner stone wall was opened, no brick core was revealed, flouting the earlier theory.

Center
Due to the movement of the corner stones large gaps were visible.

It was recommended to rake out the old joint carefully by hand in order to avoid damage to the stones. The depth of pointing was to be sufficient to hold the new mortar. Correct tools were to be used for this. It was recommend to flush out the open joint with a jet of clean water, damp it down, and fill with compatible lime mortar as advised. If the joint was too big, some aggregates or stone pieces, of matching colour and properties, were to be inserted to reduce cracking on drying. Care was to be taken to avoid any spilling of the mortar on the stone surfaces to prevent staining. Colour, texture, and thickness of the mortar was to match the original mortar. Natural pigments could be used to give the correct colour. Proper curing was to be done after application.

Left
The gaps between the stones were filled with mortar and new stone pieces.

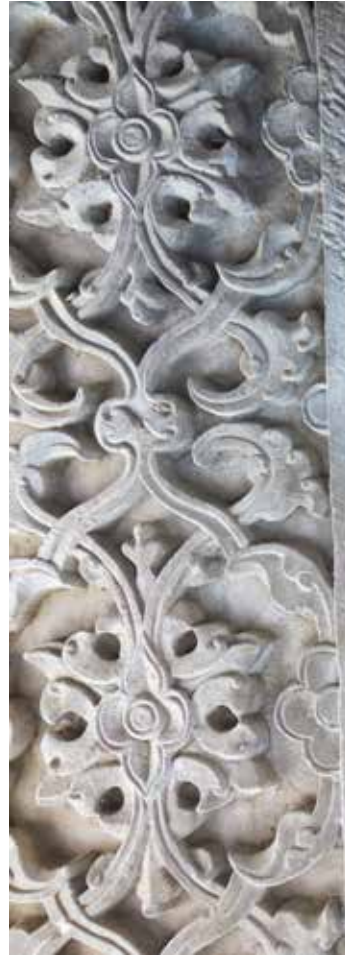
Left
The opening of eastern portal
fitted with one single piece of
intricate stone lattice panel.
(Photo:: KVPT. Jan 11, 2018)
